DEPARTMENT OF TRANSPORTATION

Contract #: 04-0120F4Cty: SF/ALA Rte: 80 PM: 13.2/13.9File #: 69.28**WELDING INSPECTION REPORT****Resident Engineer:**Siegenthaler, Peter**Address:** 333 Burma Road**City:** Oakland, CA 94607**Report No:** WIR-019533**Date Inspected:** 26-Jan-2011**Project Name:** SAS Superstructure**OSM Arrival Time:** 700**Prime Contractor:** American Bridge/Fluor Enterprises, a JV**OSM Departure Time:** 1900**Contractor:** Zhenhua Port Machinery Company, Ltd (ZPMC), Changxing Island **Location:** Shanghai, China**CWI Name:** Mr. Qiu wen**CWI Present:** Yes No**Inspected CWI report:** Yes No N/A**Rod Oven in Use:** Yes No N/A**Electrode to specification:** Yes No N/A**Weld Procedures Followed:** Yes No N/A**Qualified Welders:** Yes No N/A**Verified Joint Fit-up:** Yes No N/A**Approved Drawings:** Yes No N/A**Approved WPS:** Yes No N/A**Delayed / Cancelled:** Yes No N/A**Bridge No:** 34-0006**Component:** Orthotropic Box Girder(OBG)**Summary of Items Observed:**

OBG Assembly Bay- 14.

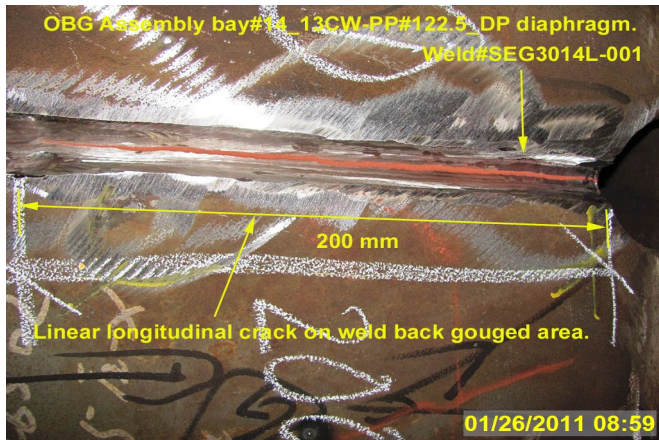
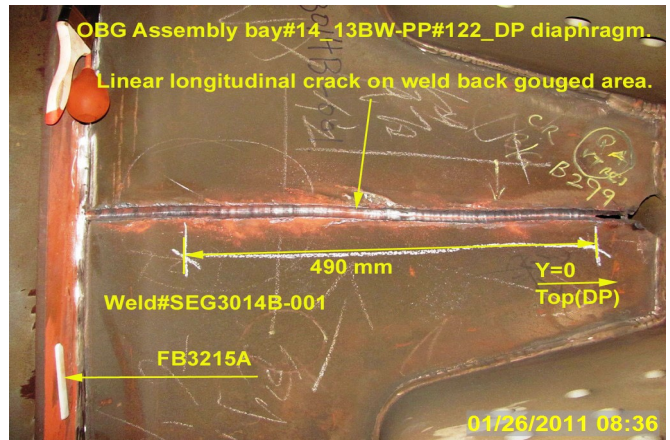
1. Segment: 13BW-Panel Point (PP) #122(Cross beam side).

- One Longitudinal Linear crack measuring approximately 490 mm in length.
- The weld is identified as: SEG3014B-001.
- This weld is Complete Joint Penetration (CJP) joining deck panel diaphragm plate to floor beam (FB3215A).
- The "Y" location is 0 from the top as shown on the picture below.

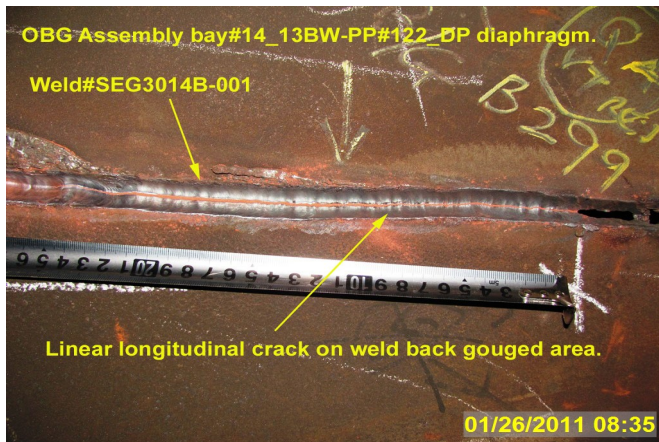
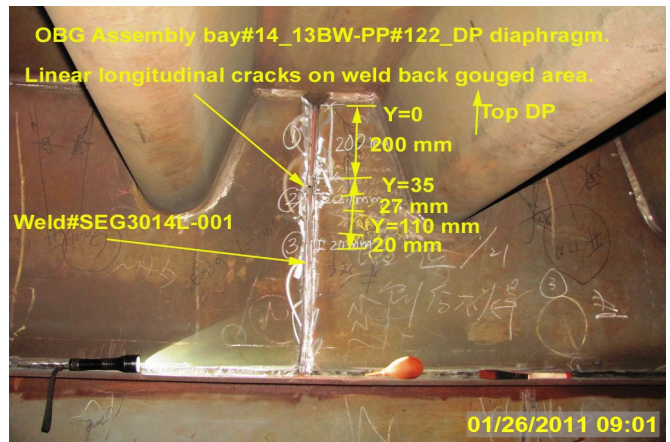
2. Segment: 13CW- PP #122.5(Cross beam side).

- Three Longitudinal Linear cracks measuring approximately 200 mm, 27 mm and 20 mm in length.
- The weld is identified as: SEG3014L-001.
- This weld is Complete Joint Penetration (CJP) joining deck panel diaphragm plate to floor beam (FB3222A).
- The “Y” locations are 0, 35 mm and 110 mm respectively from the top as shown on the picture below.

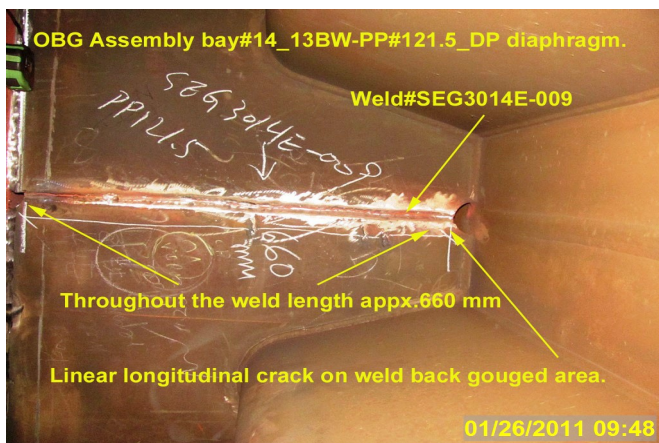
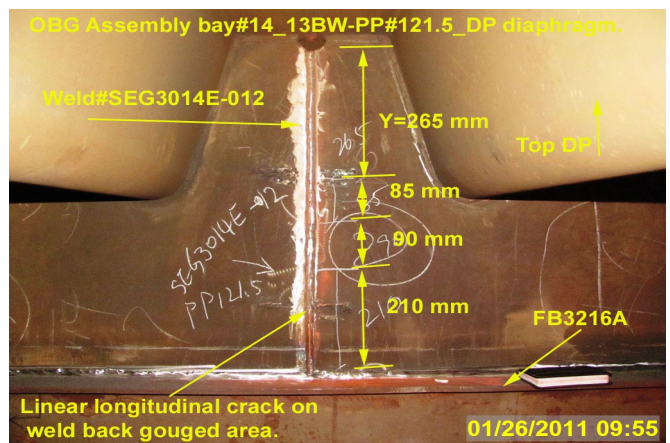
3. Segment: 13BW-PP #121.5(Cross beam side).

- One Longitudinal Linear crack through out the weld length measuring approximately 660 mm.
- The weld is identified as: SEG3014E-009.
- This weld is Complete Joint Penetration (CJP) joining deck panel diaphragm plate to floor beam (FB3216A).
- The “Y” location is 0 from the top as shown on the picture below.

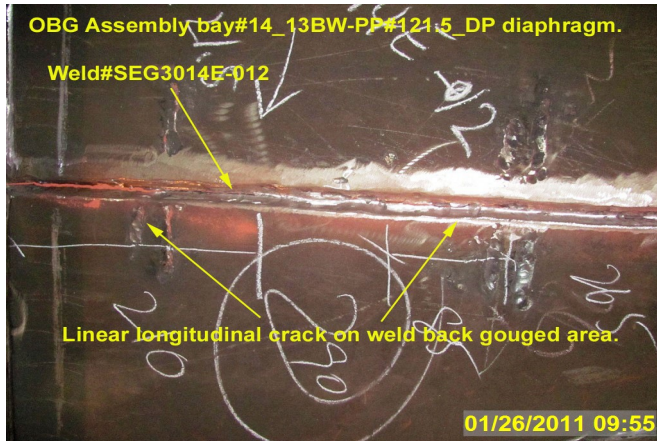
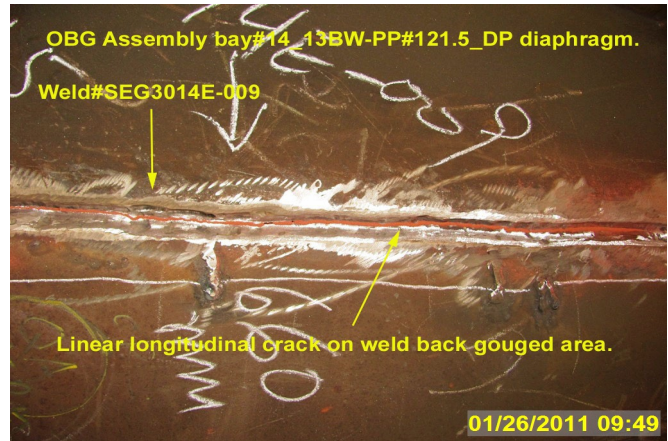
4. Segment: 13BW-PP #121.5(Cross beam side).

- Two Longitudinal Linear cracks measuring approximately 85 mm and 210 mm in length.
- The weld is identified as: SEG3014E-012.
- This weld is Complete Joint Penetration (CJP) joining deck panel diaphragm plate to floor beam (FB3216A).
- The “Y” locations are 265 mm and 90 mm from the top as shown on the picture below.
